# Manhole Inspection Summary

Manhole # S13AA2009MH

**Location** Address: **5610 GREENSPRING AVE**

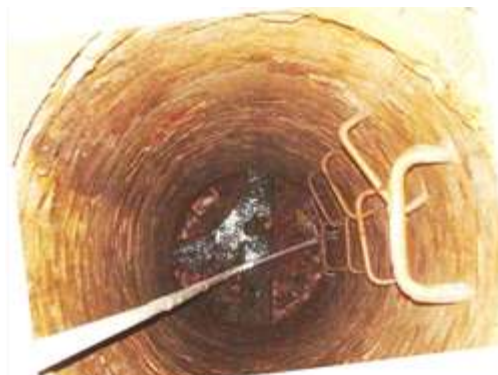
Top View

Corroded steps. Evidence of surcharge - Bench debris. Channel debris.

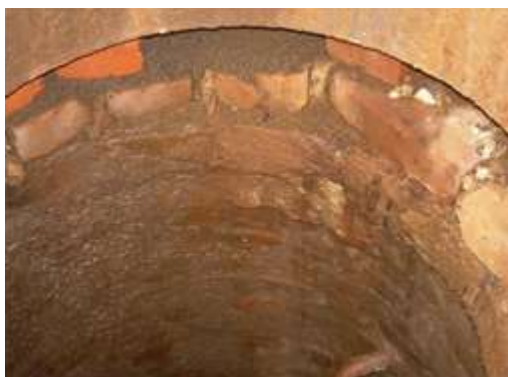
Defect

Frame offset. Adjustment deterioration and infiltration. Corbel infiltration.

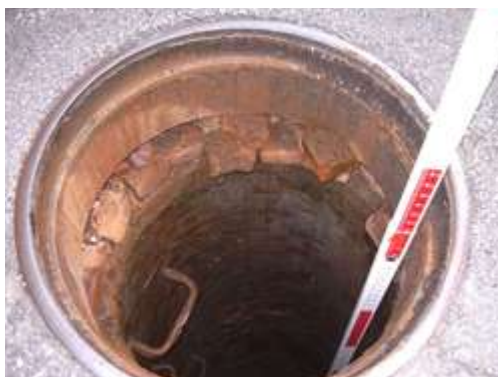
Defect

Frame leaks. Frame offset. Adjustment deterioration, loose brick, and infiltration.

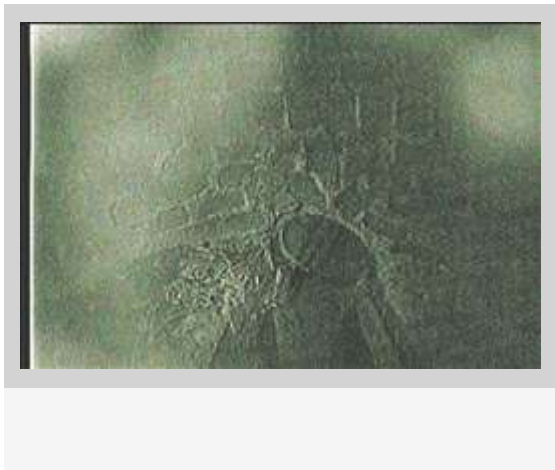
8 in. Circular Gravity Sewer  
Pipe In @ 9 O'Clock

Infiltration: **Evidence** Pipe Seal Cond: **Cracked**
